## Epoxy Systems Curb Cavitation Threat

### Polymeric composites and coatings transform heavily corroded rudders

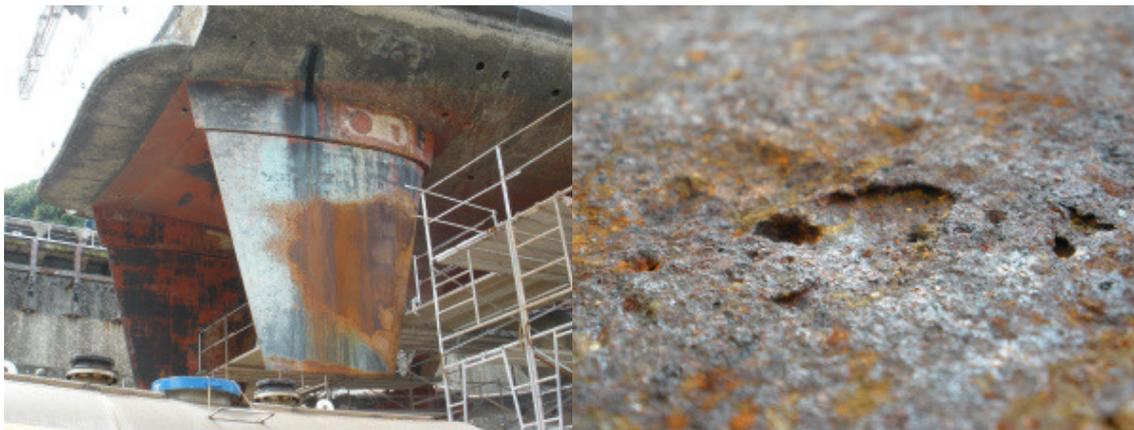
Suffering with erosion and corrosion pitting damage, the rudders on a vessel at a US navy base in Japan were in urgent need of a long-term, cavitation-resistant solution. While extensive maintenance work was needed, totalling a surface area of 58m<sup>2</sup>, the navy base required the application to be carried out with as minimal downtime as possible, so as not to impede on the vessels operations.

Metal pitting caused by cavitation and corrosion

Due to its simple and quick application procedure, the navy base decided to repair and protect the damaged rudders with a combination of cold-curing Belzona polymeric systems. Following inspection by Belzona representatives, Belzona Technical Services Engineer, Yusuke Nishi said, "It was decided that the pitted areas should be rebuilt using Belzona 1311 (Ceramic R-Metal). This ceramic filled, epoxy-based composite will provide the level of strength and durability necessary to ensure the substrate will remain robust, even when subjected to the aggressive marine conditions. To encapsulate this, a corrosion-resistant coating, Belzona 1341 (Supermetalgilde) was chosen. Finally, two coats of Belzona 2141 (ACR-Fluid Elastomer) were further specified. The flexible yet robust properties of this elastomeric system will enable the rudders to resist cavitation, even at ultra-high velocities, successfully fortifying the vessel for the long term."

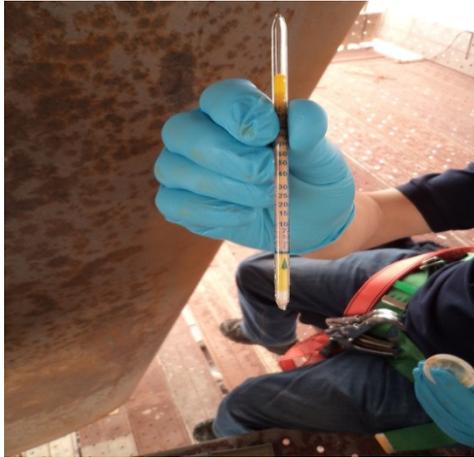
Substrate tested for Chloride content

- 1) Firstly, the rudders were sprayed using a high pressure (41.4 - 68.9 MPa/ 6,000 - 10,000psi) water jet to remove all loose rust and chlorides. The substrate was then tested using an Elcometer 134S (Chloride Ion Test Kit) to ensure the chloride content was less than 20mg/m<sup>2</sup>.

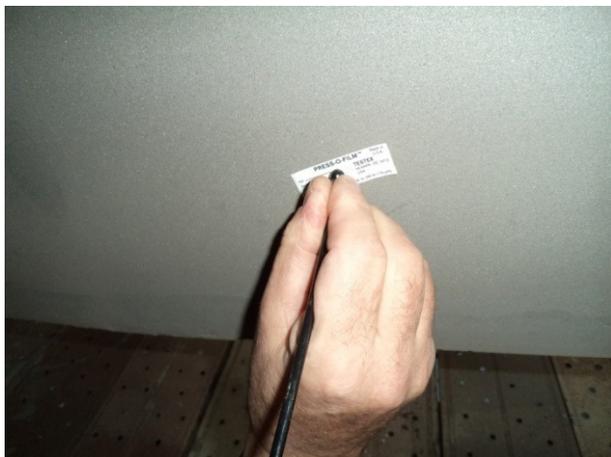
Surface profile test

- 2) The substrate was then grit blasted to give Swedish Standard Sa2 ½ (near white metal finish), ensuring a 75-125 µm (3-5 mil) profile was achieved. Using Testex replica tape, the surface profile was measured to ensure the correct surface profile, as detailed above, was achieved.

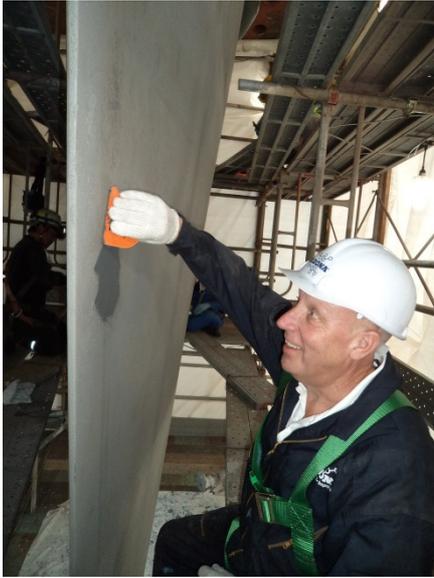
Pit filling with Belzona 1311

- 3) Belzona 1311 was then used to rebuild the pitted areas back to the original dimension of the rudder, taking care to fill in the pits correctly and to leave a smooth surface free of ridges.

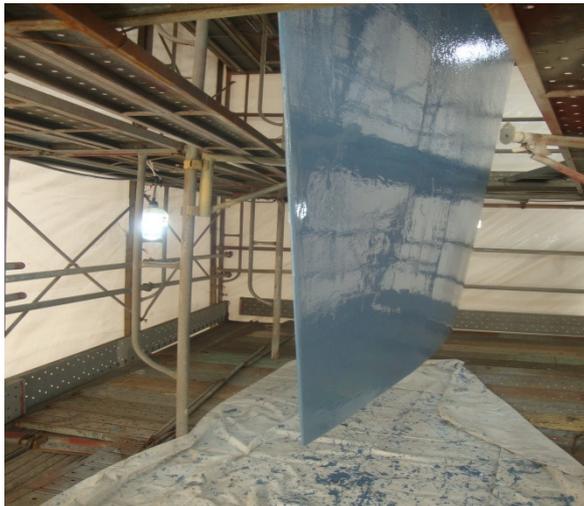
Anti-corrosion coating Belzona 1341

- 4) Next, Belzona 1341 was applied on all cavitation damaged areas with a single 250µm (10mil) coat. After eight hours, once the coating was firm and dry, the area was over coated with Belzona 2941 (SP Conditioner). To ensure this was applied as thinly as possible, a brush with bristles 12mm long was used.

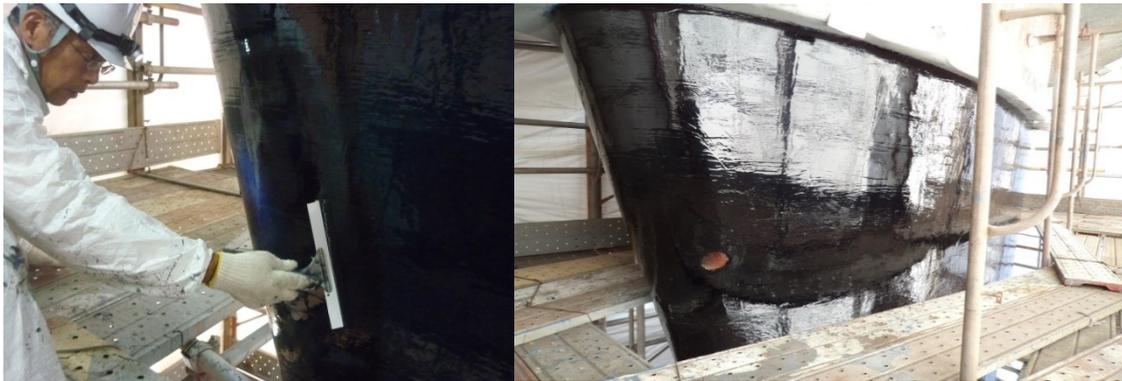
First coat of Belzona 2141 applied      Application completed

- 5) Finally, Belzona 2141 was applied in two coats (black on green). This flexible elastomeric system was applied to the substrate with a thickness of 500-750µm (20-30mil) per coat.
