Superior Composite Technology Developed for Pipe and Tank Repair and Protection

Already with a 100% application success rate, Belzona's high-tech pipe wrap repair system has undergone a major reformulation and enhancement.

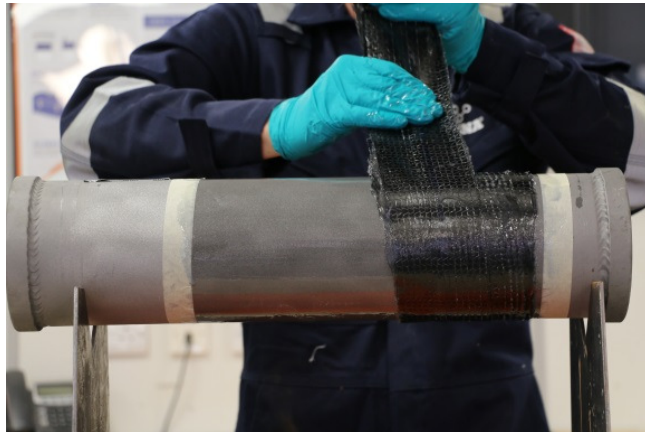
[Application of SuperWrap II on pipe spool]

- 1) First apply the selected resin grade product, Belzona 1981 or Belzona 1982, to the blasted substrate.
- 2) On to this, the Belzona 9381 reinforcement sheet, wetted with the selected low density resin (Belzona 1981 or Belzona 1982), is spiral wound onto the repair area, adding strength.
- 3) When all wraps have been applied to specification, further resin grade product is then applied on top of the reinforcement layers if required.
- 4) The repair is then consolidated by tightly wrapping the Belzona 9382 Release Film over the repair area, ensuring a high quality laminate, with no air entrapment or voids.

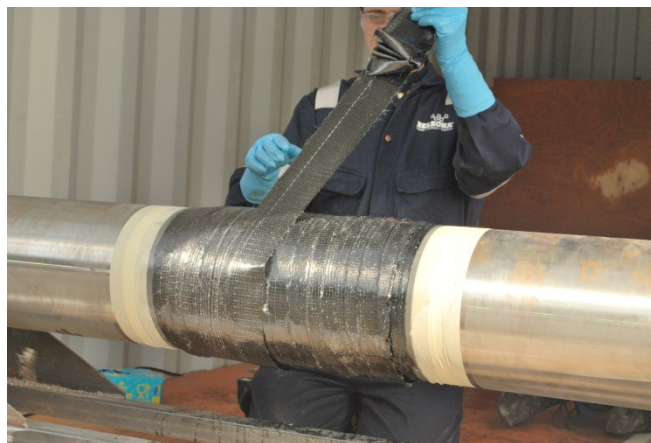
[Pressurised to target pressure of 39.2MPa, pressure taken 5% over, no failure seen, but substrate began to yield]

During the Annex C test (ISO 24817) and Appendix III (ASME PCC-2 Article 4.1), a test designed to rebuild the damaged section of pipe back to its original yield strength, the repair withstood the calculated yield pressure of the substrate, whilst the original steel profile showed signs of yielding.

The test involved machining a 125mm x 62.5mm rectangular defect into a 250mm diameter pipe (2000mm in length). The original wall thickness of the pipe was 10mm, and in the defect area this was reduced to 2mm. The yield pressure of the undamaged spool was calculated to be 39.2MPa, a repair was engineered to restore the pipe to this original pressure.

The repair was applied to specification and the pipe was then pressurised up to 39.2MPa, without failure, demonstrating that the Belzona SuperWrap II had performed as designed. Pressure was then increased to determine where a yielding would occur – in the repair or in the original pipe. At around 42MPa, the pipe clearly yielded, outside of the repair area. This demonstrated that not only had the wrap returned the pipe to its original strength, it had also made the defect area stronger than the original pipe section.

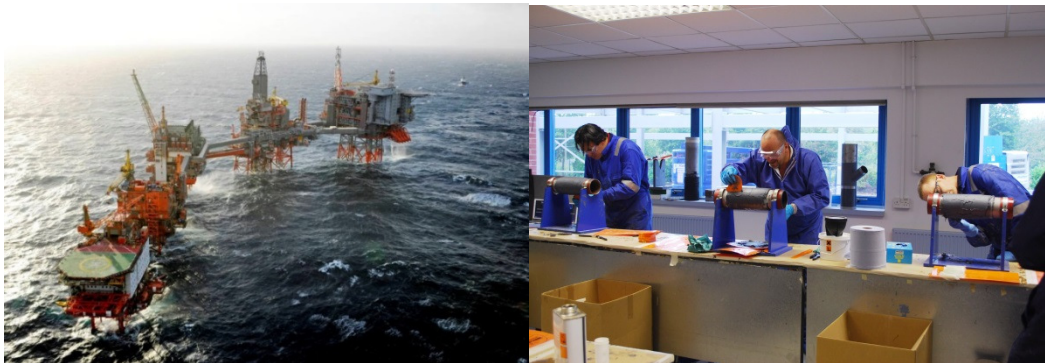
[Belzona SuperWrap II can be used in a variety of application areas]
[Theoretical and practical training available at Belzona head offices]
